**ROCKY MOUNTAIN ARSENAL**

FINAL  
TECHNICAL PLAN  
VERSION 3.1

TASK NO. 10  
SEWERS AND PROCESS WATER SYSTEM INVESTIGATIONS

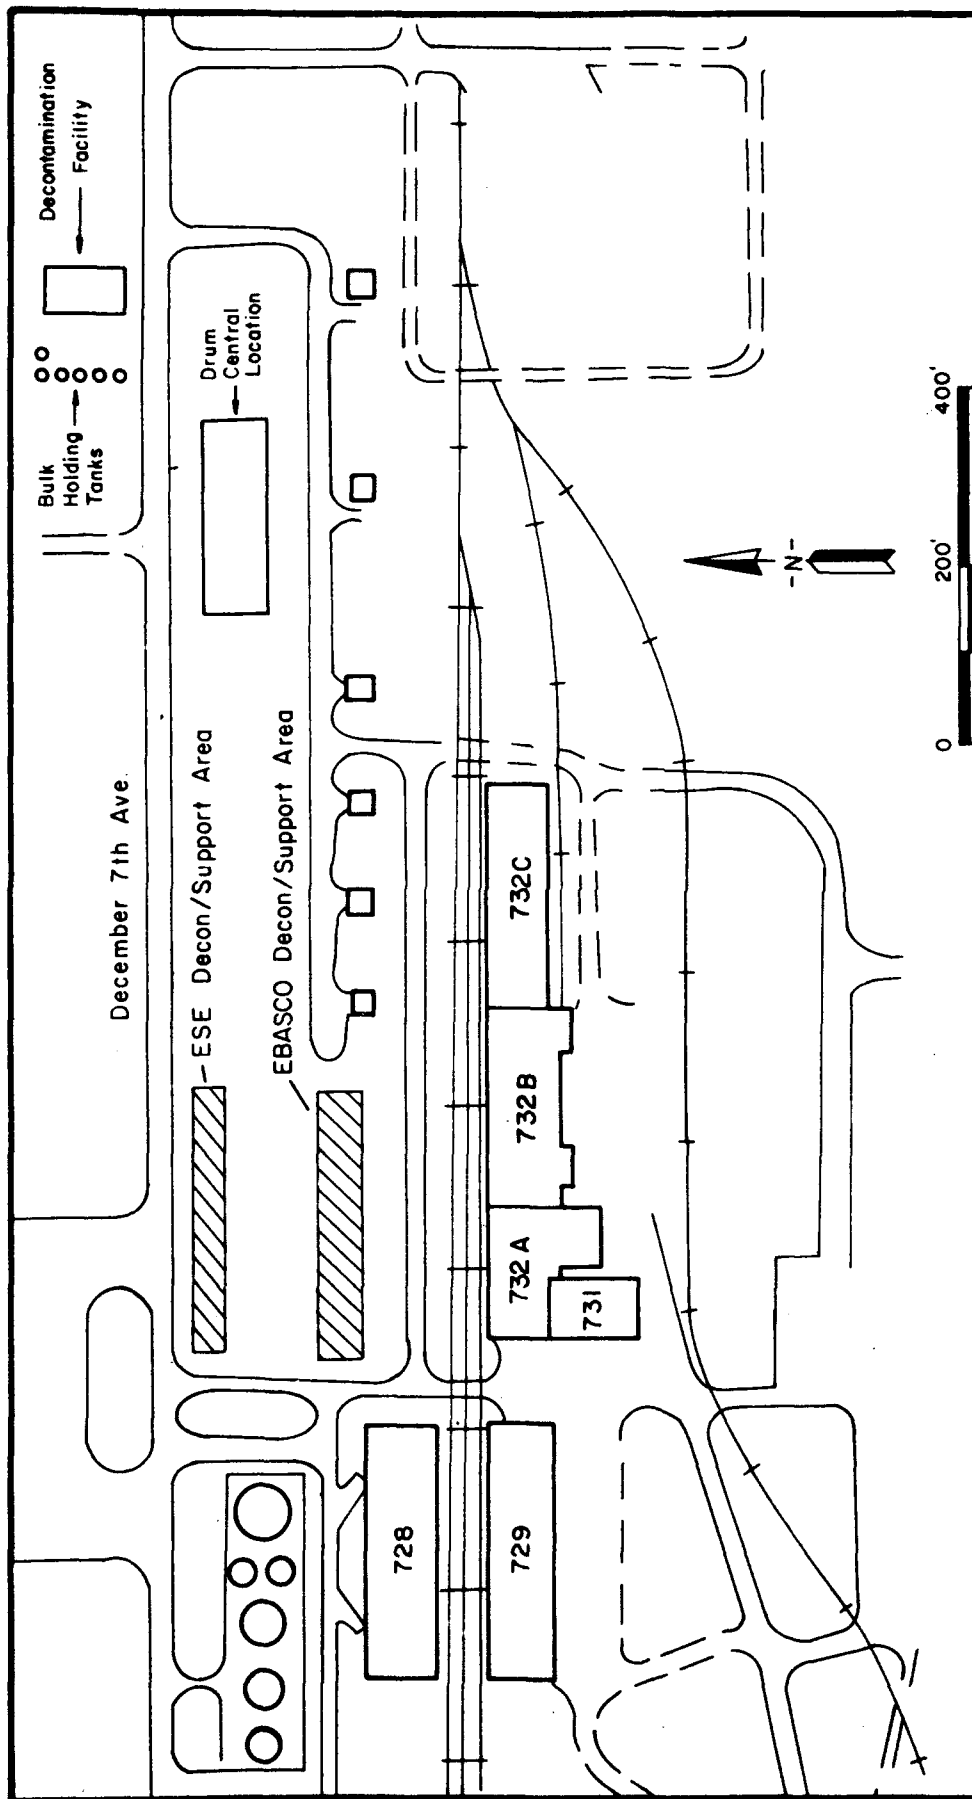
Heated and lighted warehouse space has been provided by RMA for the use of both Ebasco and ESE. The eastern half of Building 728 (see Figure 3.1-1) has been made available for this purpose. This building has been divided in half by a firewall and RMA has further subdivided the eastern half into three approximately equal areas by chain link fences. The central area is being used by RMA for miscellaneous equipment storage. The two outer areas will be used by Ebasco and ESE. Each of these outer areas can be accessed through separate 12-ft doors from separate loading docks on the northern side of the building.

In addition to Building 728, RMA has provided warehouse space in Building 733-C for storage of some sample cores obtained during this task. Potentially hazardous solid materials such as used protective clothing are placed in drums, which are subsequently placed on pallets in Building 732.

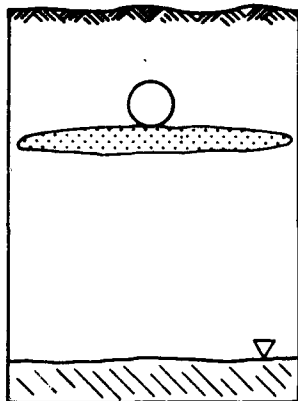
**Horizontal  
Contaminant Migration**

The tracer to be used for the dye testing procedure will be Rhodamine B, a red dye which should visibly stain the soil. This staining will indicate possible migration patterns of liquids exfiltrating from the sewer lines. The migration pattern of the dye is not expected to follow the total migration pattern of leaking contaminants, but it is expected to give an indication of the contaminant migration pattern. These patterns are critical for understanding where the contaminants may have migrated. Possible patterns, as illustrated in Figure 3.3-1, include horizontal migration along the sewer lines and downward vertical migration away from the sewer lines. The dye stains will also indicate where soil samples should be taken to document contaminant exfiltration.

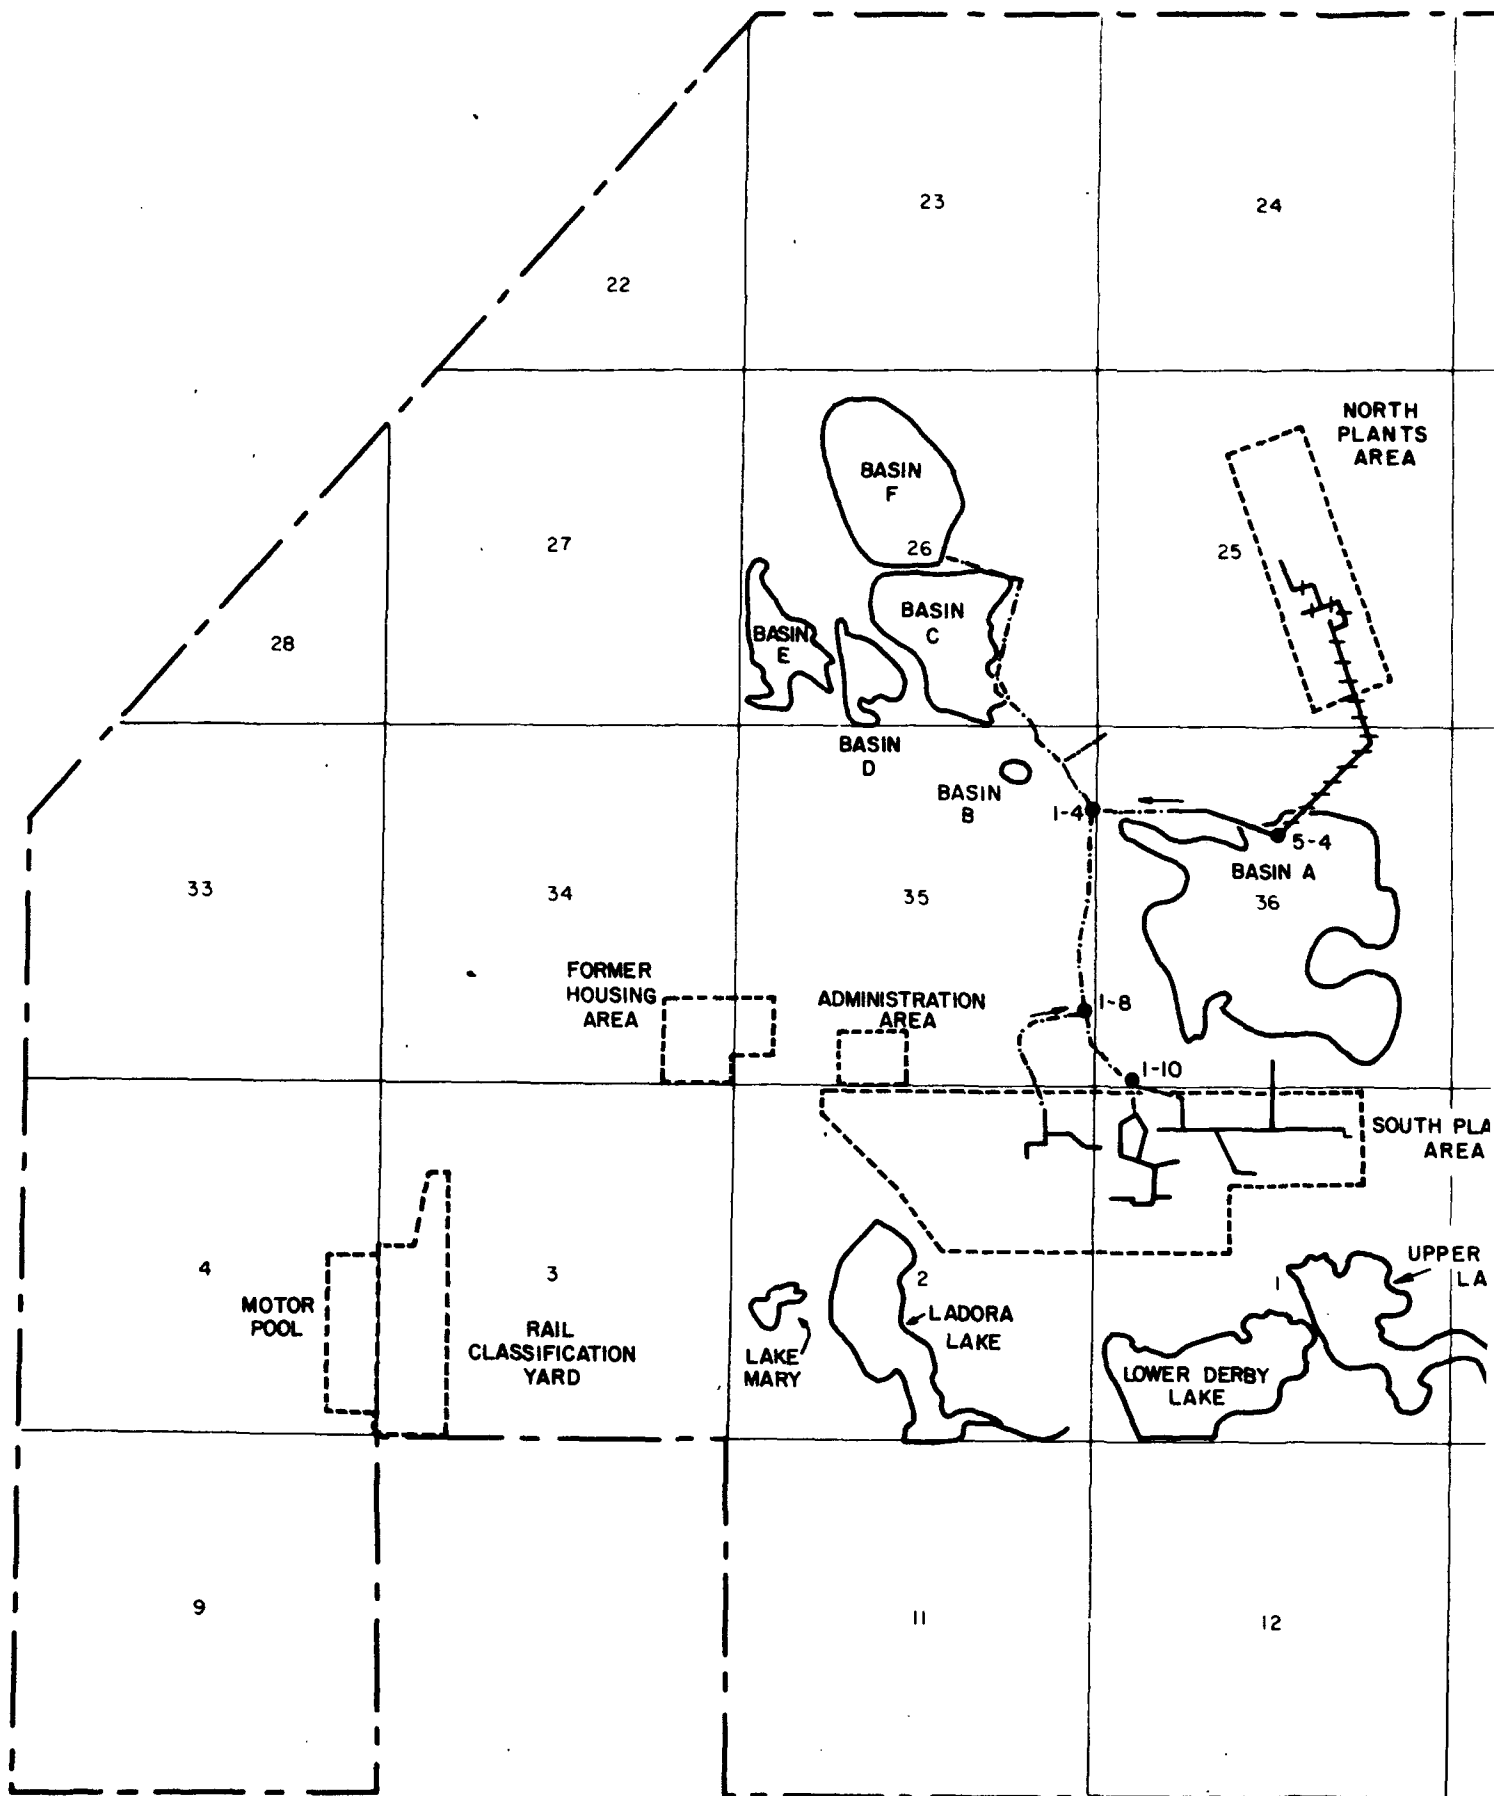
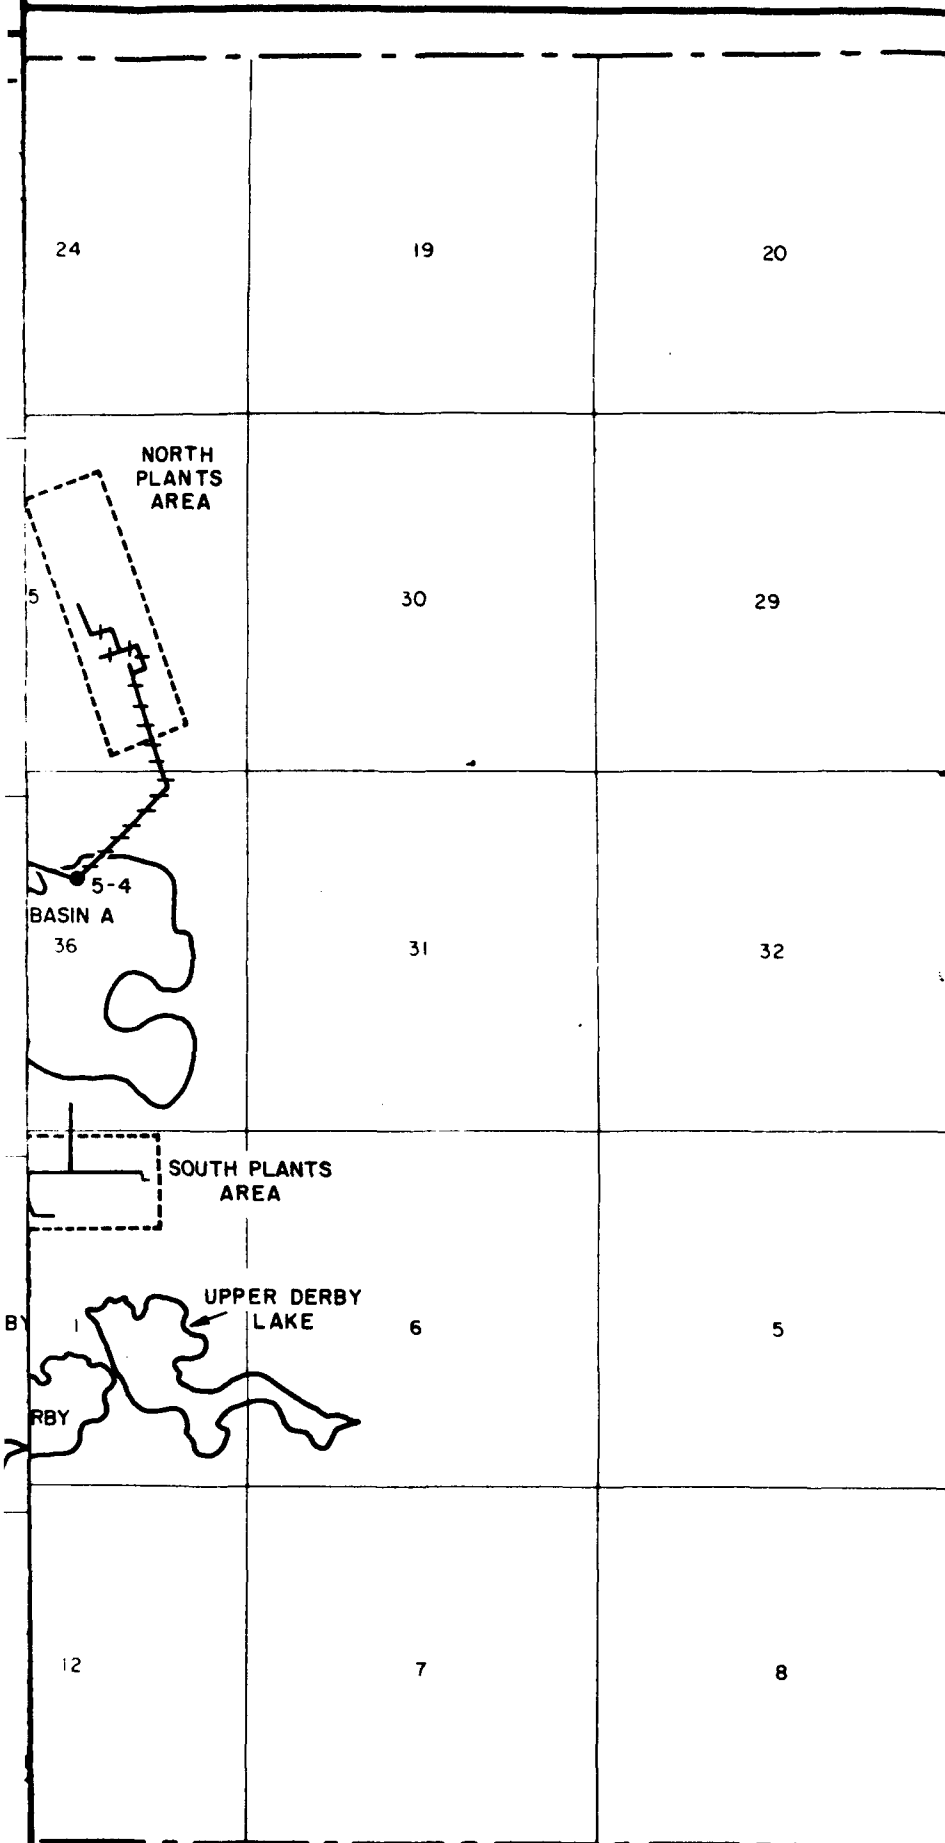
Most of the below-ground chemical sewer system was built in 1942. Figure 3.5-2 displays the South Plants area chemical sewer system. It is constructed primarily of 5-ft lengths of VCP varying from 4 to 12 inches in diameter with oakum-cement joints. Although the chemical sewers are primarily a gravity system, several force mains exist in the system. In the early 1980s, the Army stopped using the gravity system and constructed several steel force mains leading to a local waste treatment facility in the South Plants (the South Plants Laboratory Waste Treatment Facility).

- Contaminated Waste Main
- - - Waste Main Removed by the Army in 1982
- 1-8 Manhole with Number
- Direction of Flow
- ++++ Steel Sewer Lines

NOTE : All contaminated waste pipes are vitrified clay unless otherwise noted.

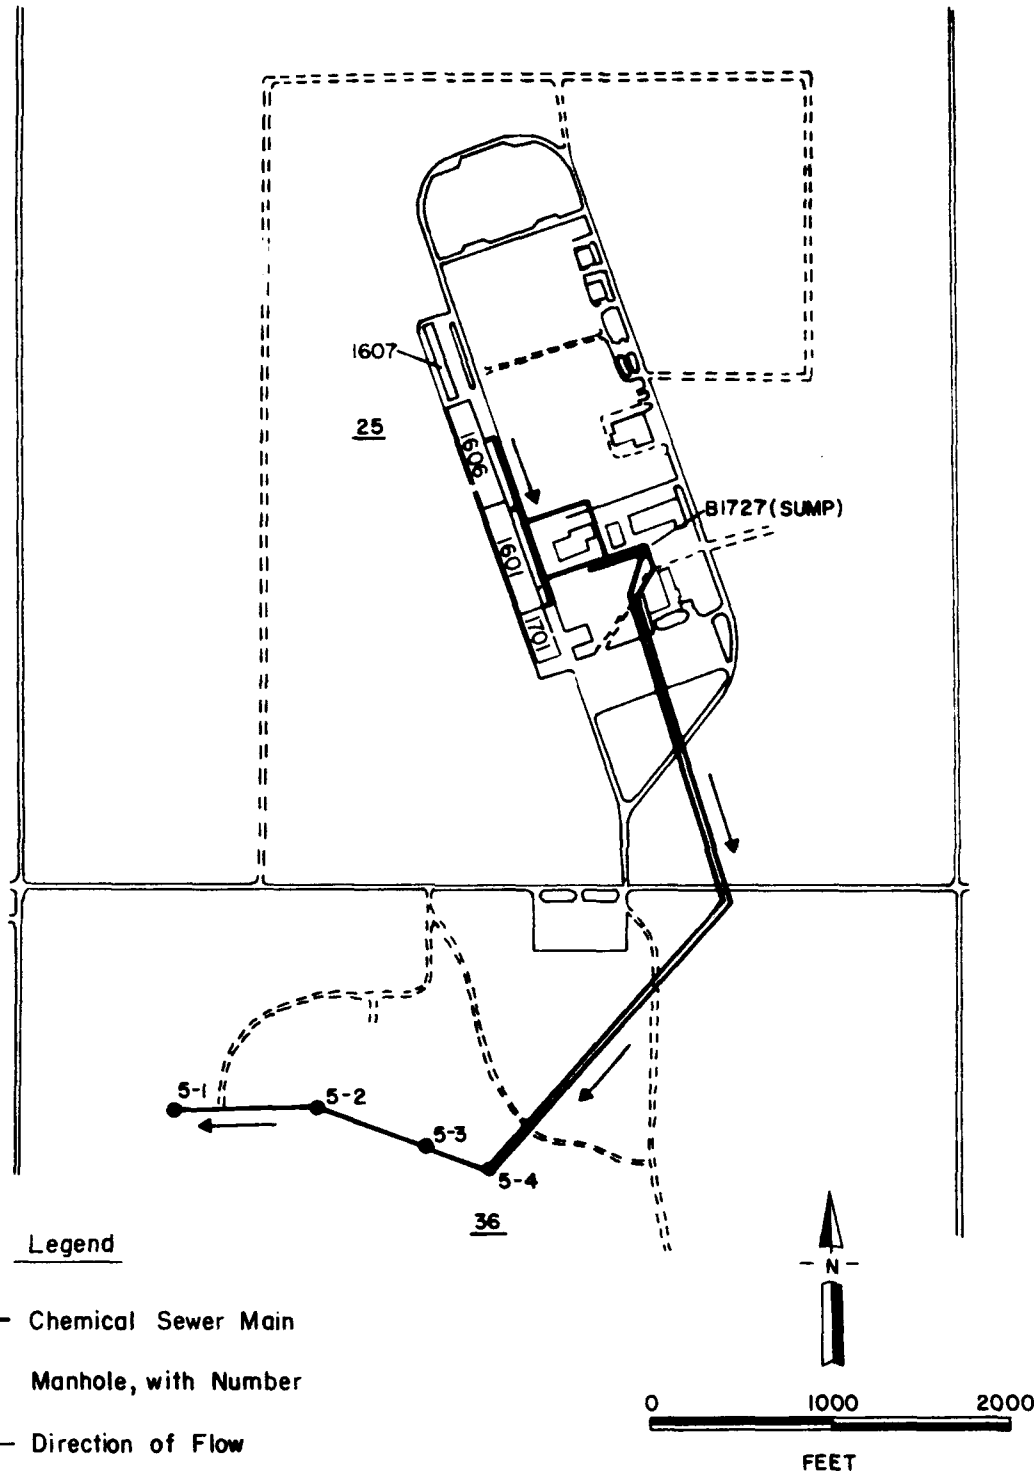
The North Plants chemical sewer system was built in 1952 along with the initial construction of the GB Plant. Cast iron and steel piping, rather than VCP, were used to plumb the system in this area. The system is illustrated in Figure 3.5-3.

Chemical sewer lines in the North Plants originate from Buildings 1606, 1601, and 1701, located along the western margin of the facility. The lines proceed eastward for approximately 500 ft to the lift station sump in Building 1727. Two pressure discharge lines emanate from the lift station, a 6-inch diameter cast iron line and a 12-inch diameter steel line. The two parallel lines proceed southeastward and exit the facility. After the lines pass beneath Eighth Avenue and enter Section 36, they turn southwestward toward Basin A. These lines formerly discharged into Basin A. Following construction of Basin F in 1957, VCP extensions were added to the cast iron and steel pipes to redirect downstream discharges to the new basin. This 8-inch VCP line proceeded westward across the northern portion of Section 36 (north of Basin A) and merged with the chemical sewer line from the South Plants area directly west of "D" Street. Approximately 1,600 ft of this VCP line is still intact in Section 36. This line has been plugged at Manhole 5-1. The sewer lines remaining within the North Plants facility were likewise plugged.

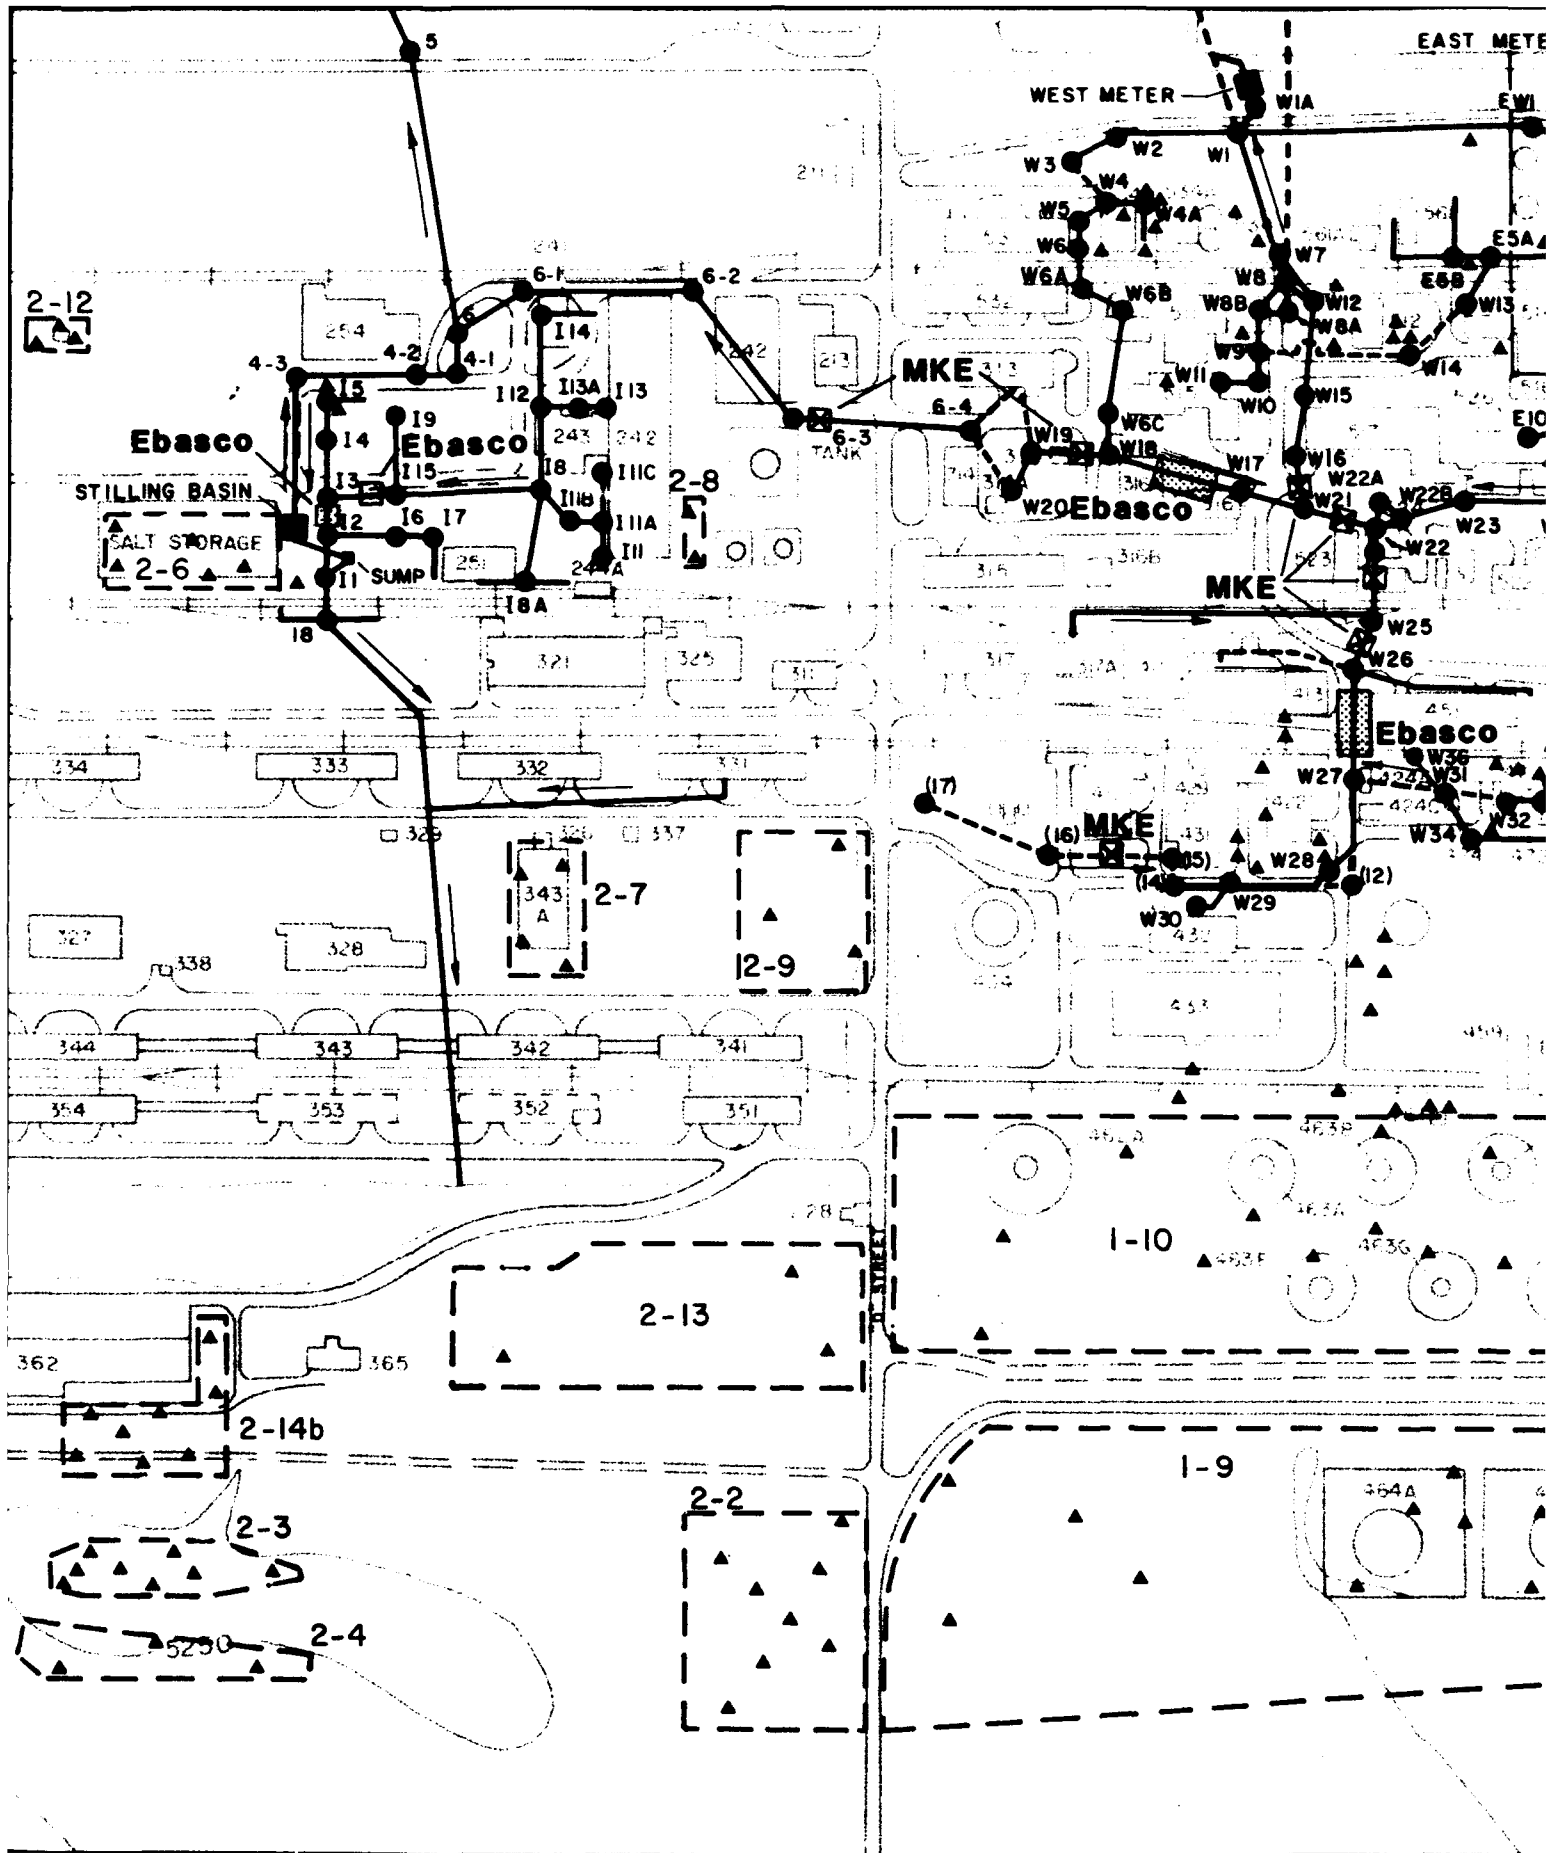
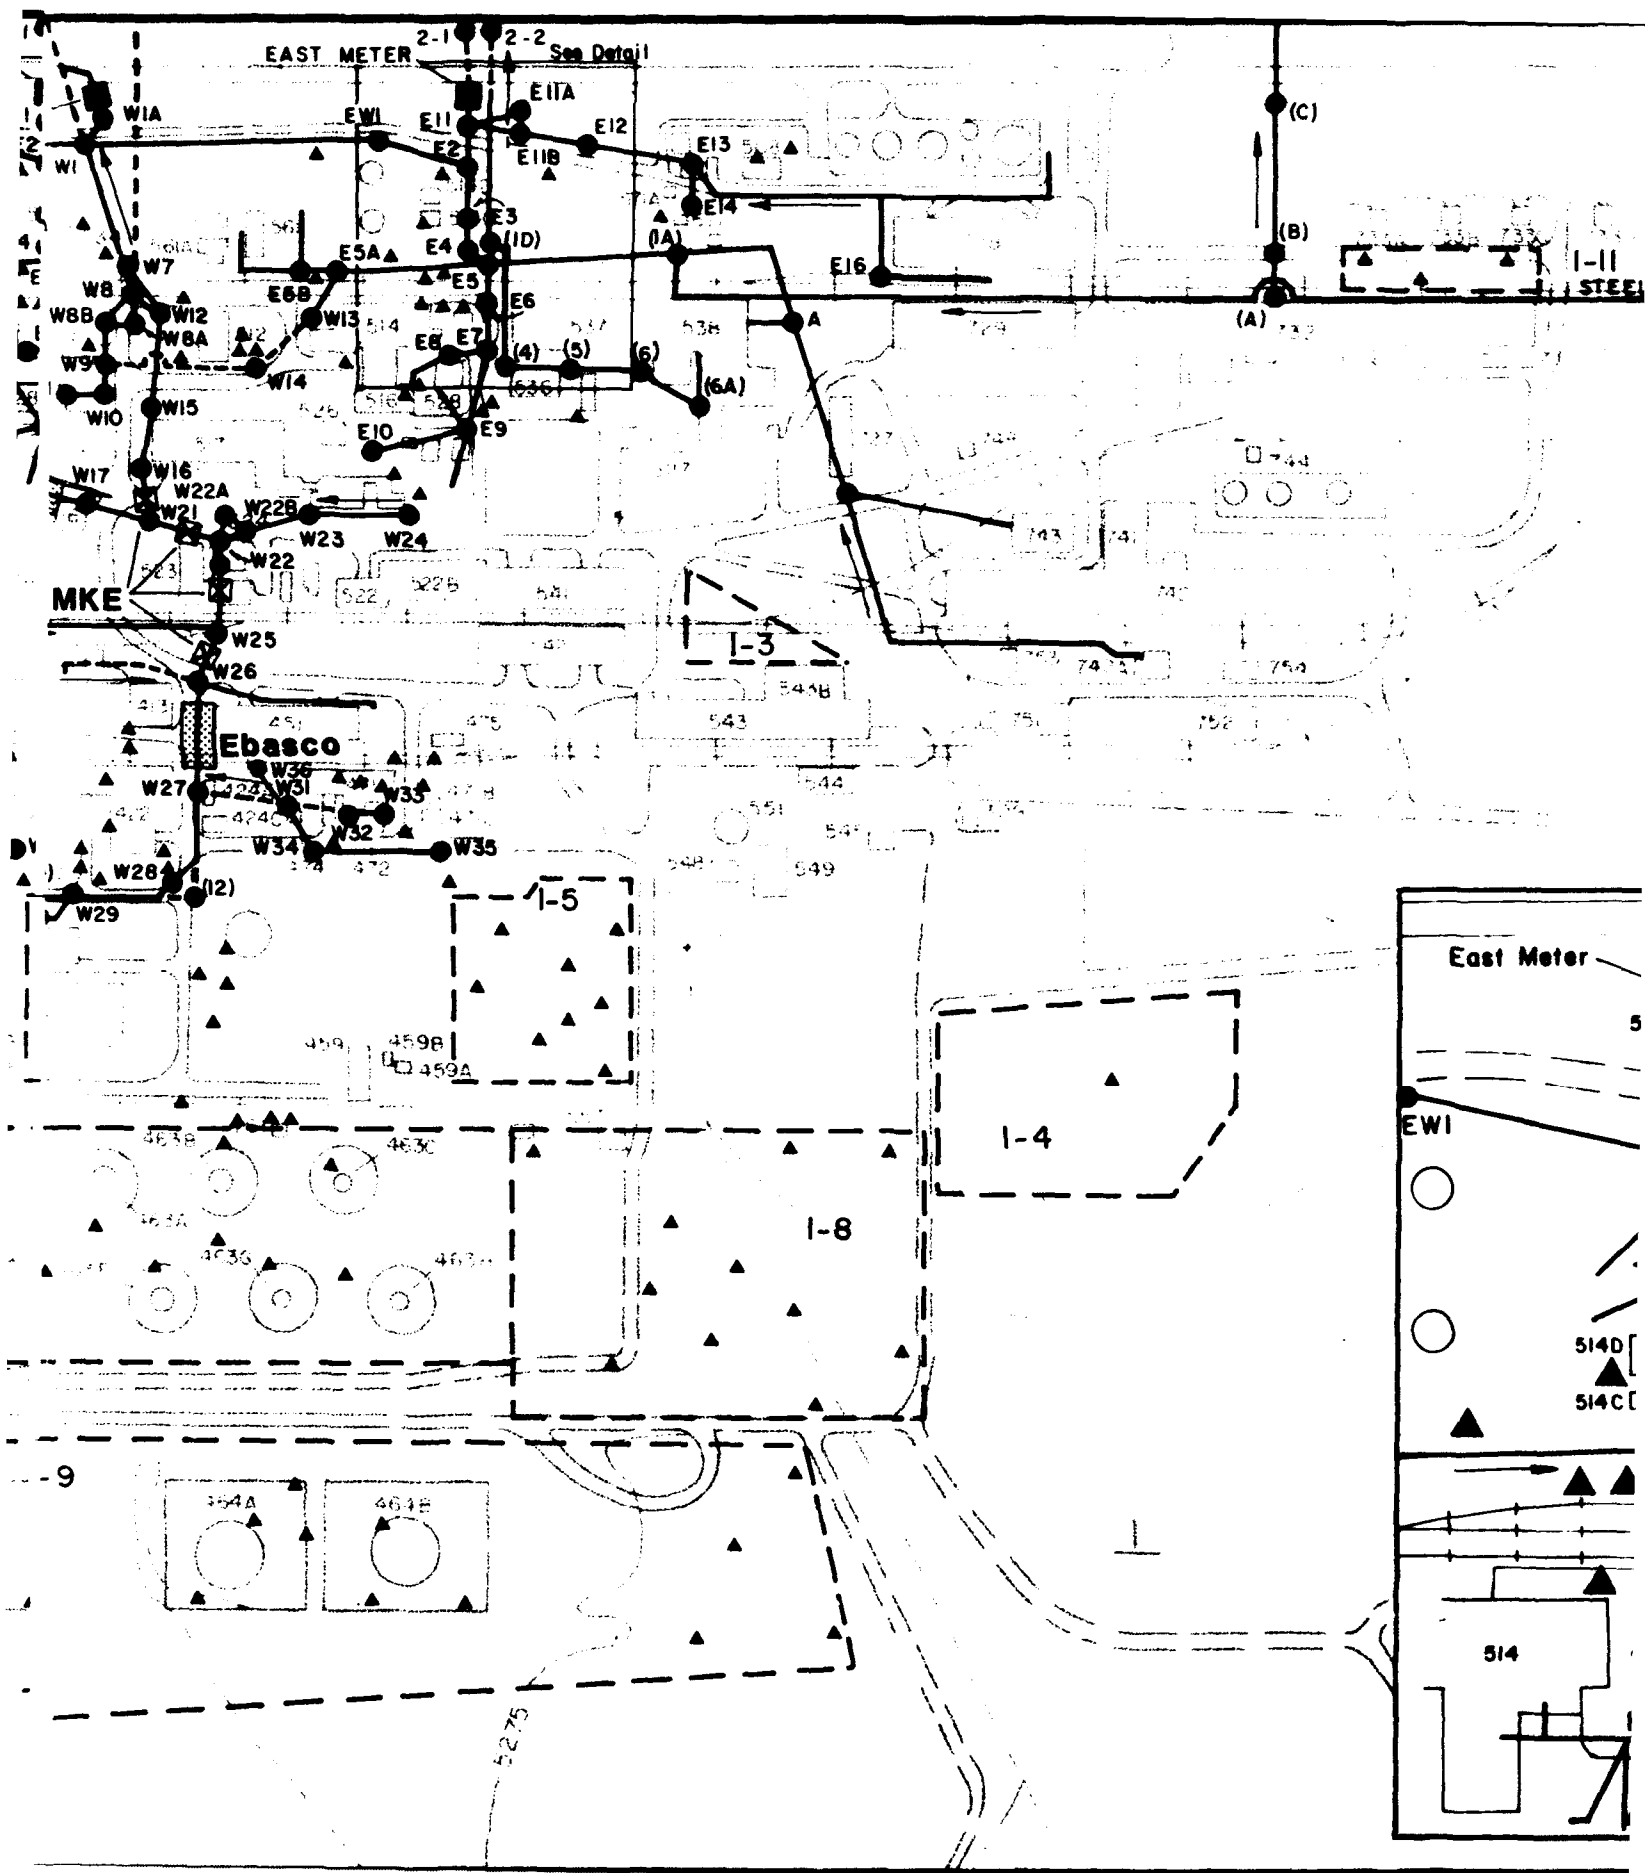
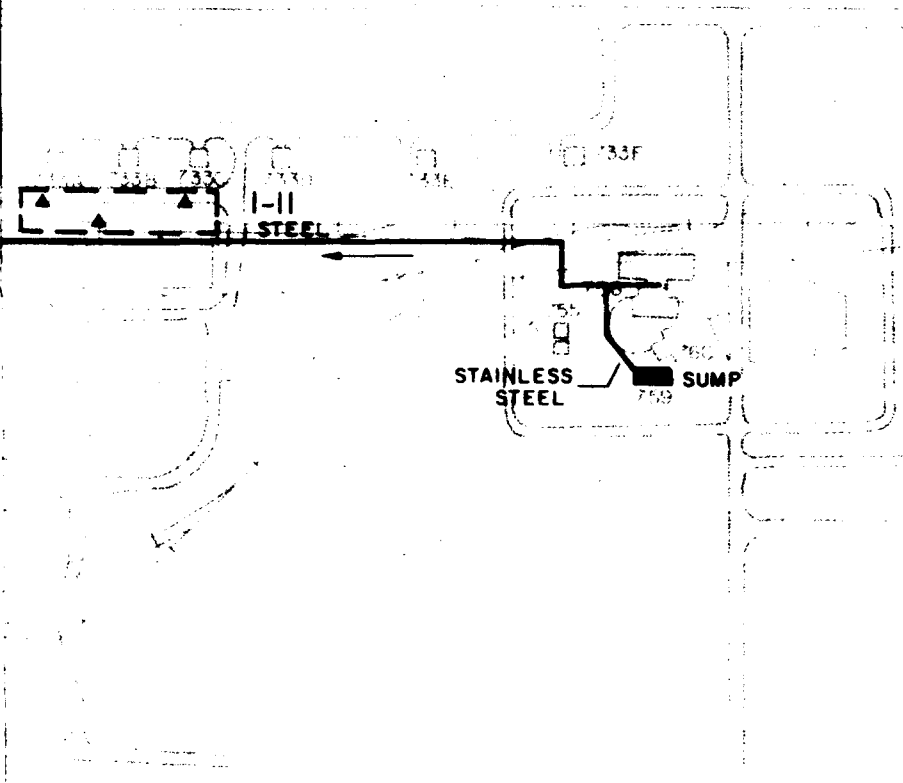
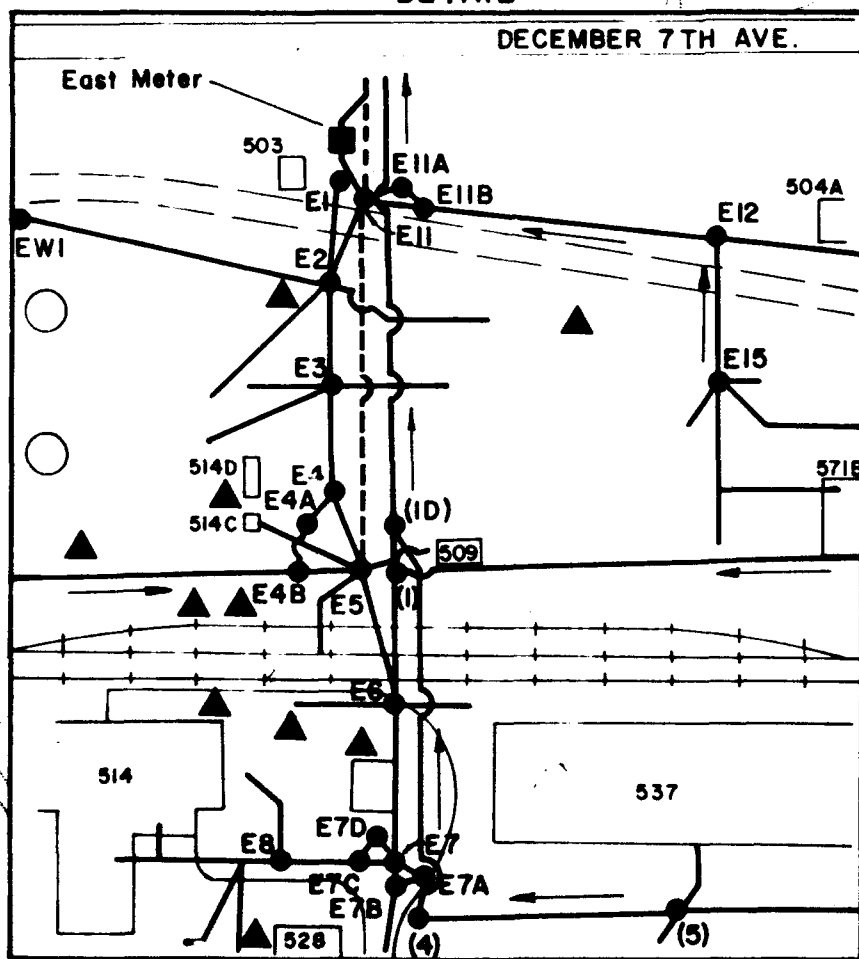
Most of the chemical sewer system located in the "core" manufacturing zone of the South Plants will not be investigated. The widespread contamination in this zone, caused by numerous spills, makes it virtually impossible to distinguish sewer-related contamination from other sources of contamination. Task 2 and its follow-up Phase II investigation has concentrated, and will continue to concentrate, on the "core" manufacturing area. Figure 3.5-4 identifies the locations of boreholes associated with Task 2.

- ▲ Task 2 Bore Location
- Proposed Excavation Site
- ⊠ MKE Excavation Site
- Contaminated Waste Main
- <sup>0</sup> Manhole, With Number
- ← Direction of Flow

1. All contaminated waste mains are vitrified clay unless otherwise noted.

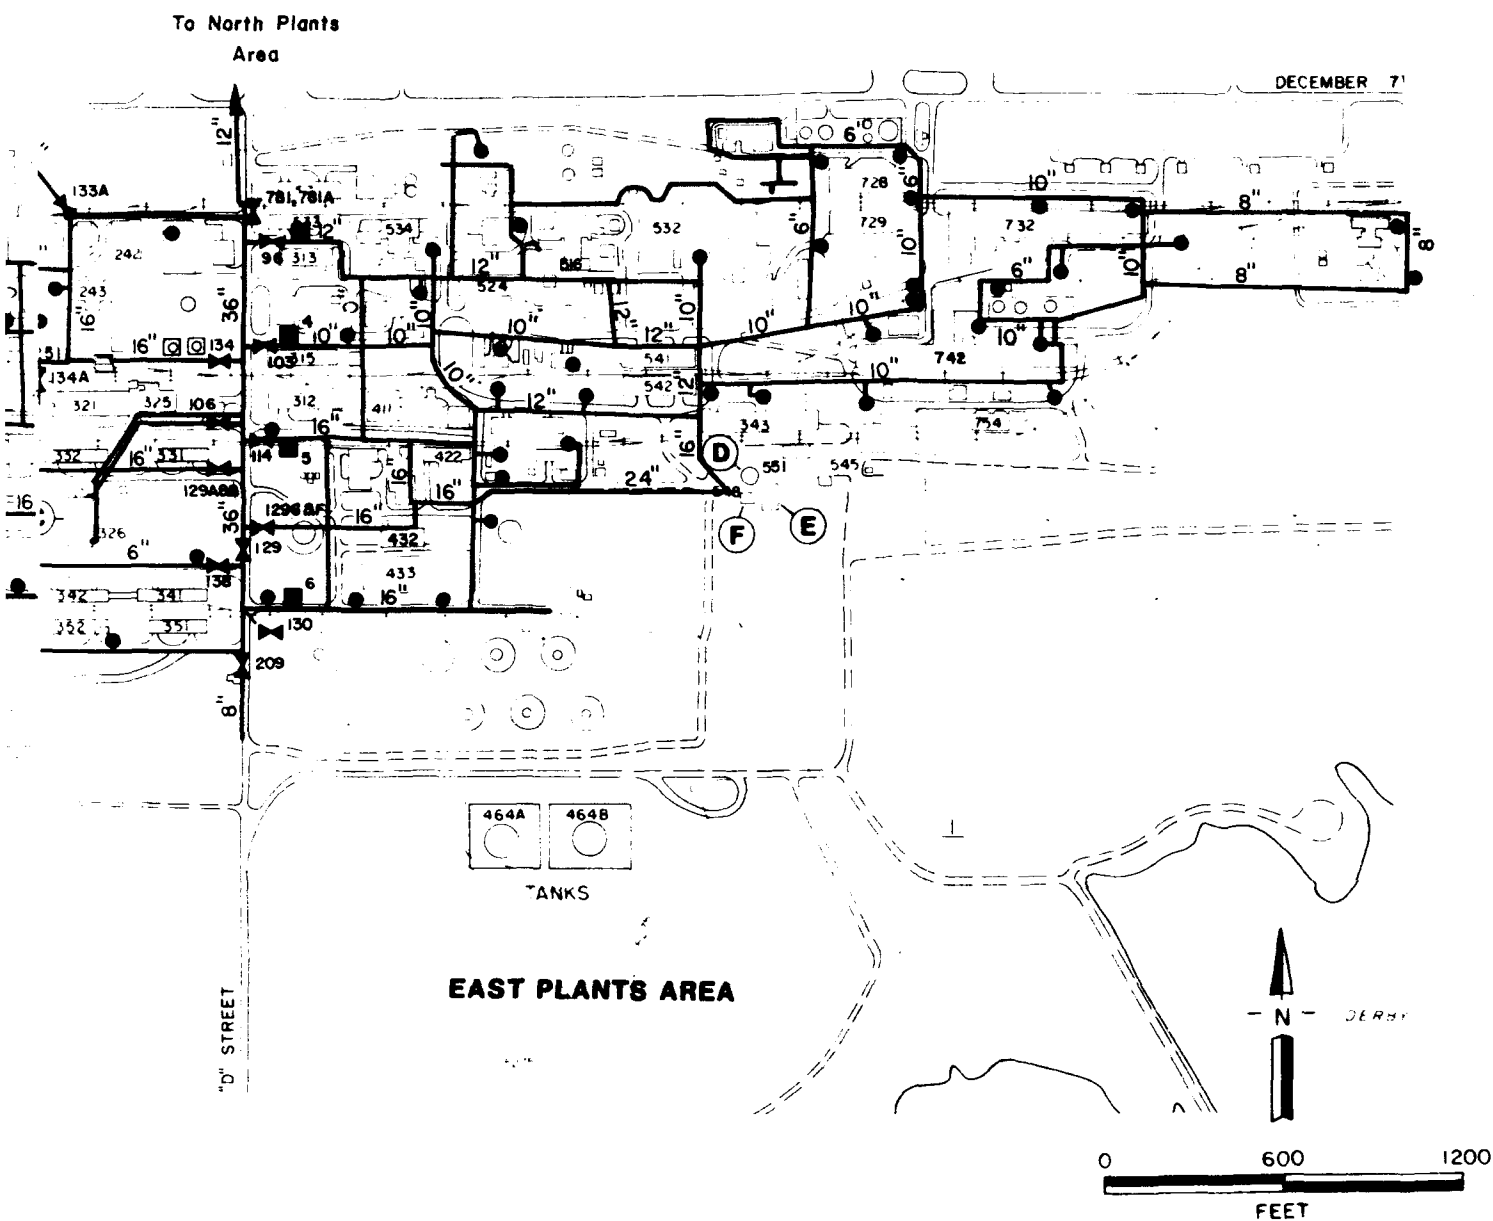
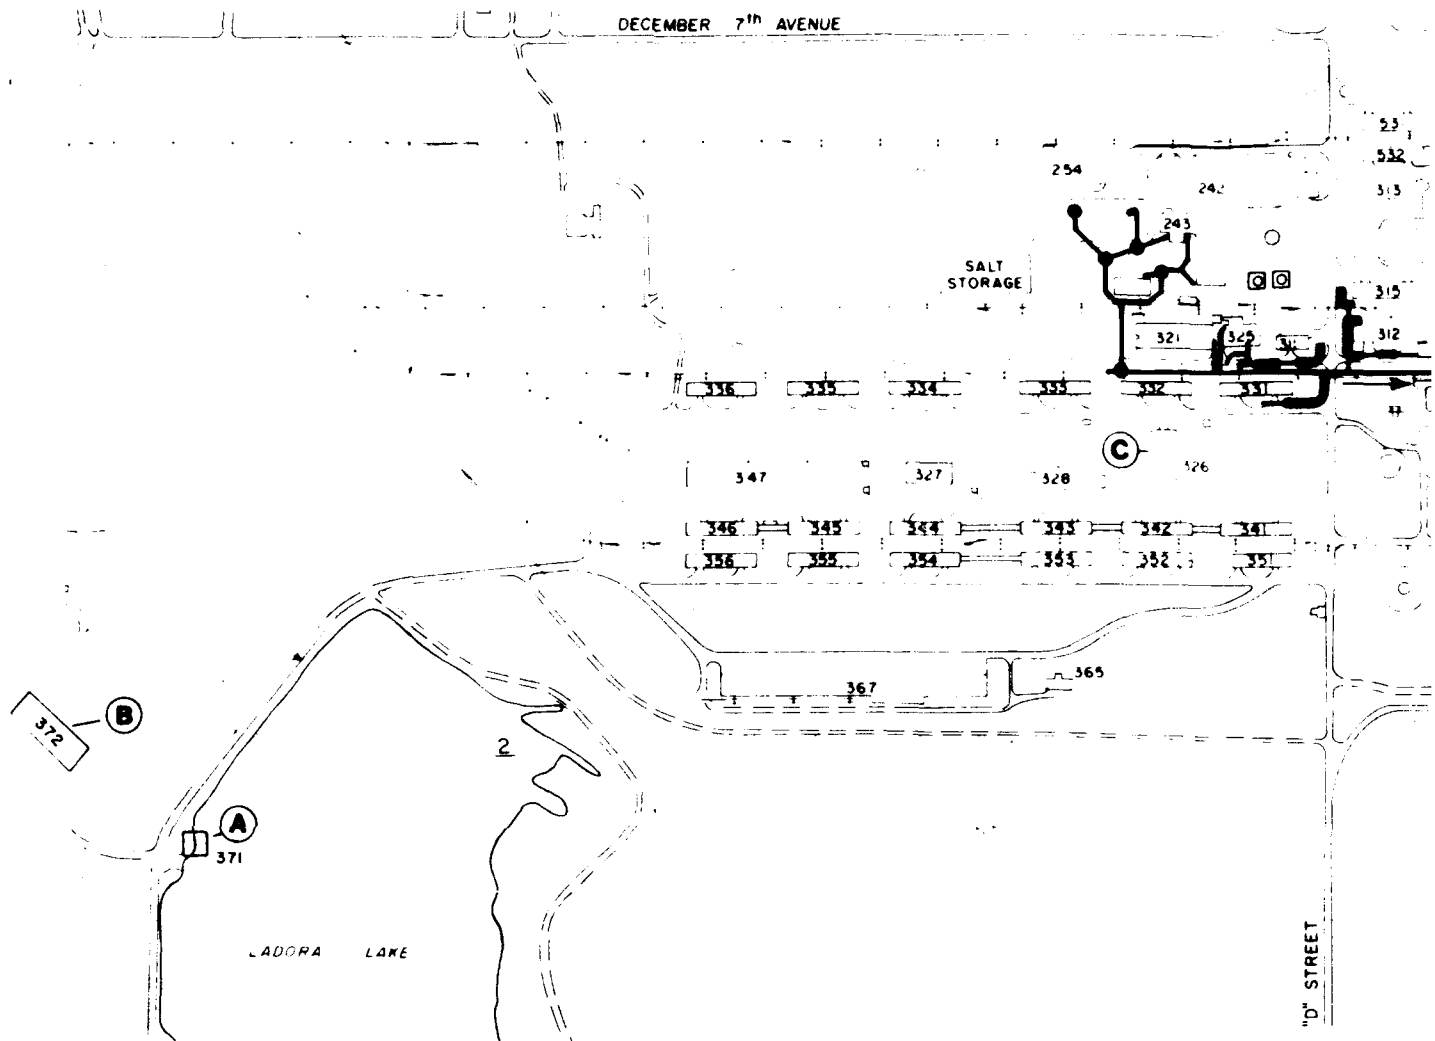
The return from the closed system discharges into a lift system instead of the lakes system (Figure 3.6-3). Two 4,000 gallons per minute (gpm) vertical turbine pumps, in the lift station, pump water to the wet well of the cooling tower pump house (Building 548). Three 3,500 gpm pumps, located in the pump house, lift process water into the cooling tower (Building 549). The cooling tower consists of a two-cell tower with a 7,000 gpm capacity. A 500,000 gallon reinforced concrete reservoir is located beneath the cooling tower. Three additional 3,500 gpm pumps, located in the cooling tower pump house, return process water from the concrete reservoir back into the process water distribution system. These pumps can also be used to lift process water into a 500,000 gallon elevated storage tank (Building 551).

| <p>Ⓐ Water Pump Station<br/>(Bldg. 371)</p> <p>Ⓑ Reservoir<br/>(Bldg. 372)</p> <p>Ⓒ Spray Pond Structure and Spray House<br/>(Bldg. 326)</p> <p>Ⓓ Elevated Water Storage Tank<br/>(Bldg. 551)</p> | <p>Ⓔ Cooling Tower</p> <p>Ⓕ Pump House<br/>(Bldg. 548)</p> |
